SI 11 10 05
Engine

Service Action: S85 Replace VANOS High Pressure Line

E60 M5 with S85 produced up to 11/22/05

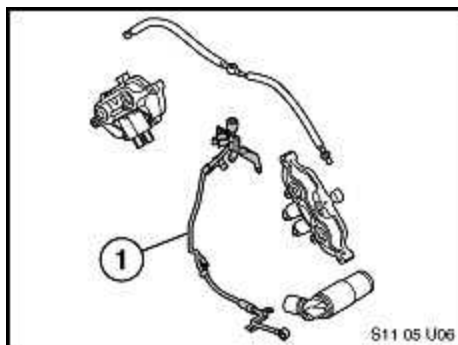
The VANOS high pressure line may start to leak engine oil around the flexible hose.

3. Remove the drive belt for A/C compressor (refer to TIS RA 1128050).
4. Remove the alternator drive belt (refer to TIS RA 1128010).
5. Disconnect the secondary air hose fitting and remove the water pump pulley
6. Carefully loosen the VANOS line at accumulator, to release any residual pressure, and then remove and replace the VANOS high pressure line: PN 11 36 7 838 670) – identified as #1 on the illustration.
7. The required tightening torques can be found in TIS under: 11 36 Variable camshaft control. All sealing rings must be replaced.

Important: Only copper sealing rings must be fitted.

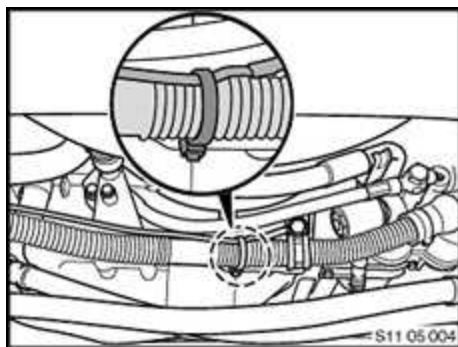
Note: When fitting the new line, make sure that there is sufficient distance to the cable tie on the secondary air hose on the bottom of the engine. If the cable tie is fitted with the lock facing upwards (towards the VANOS high pressure line) it must be replaced. When doing so, make sure the cable tie lock is positioned at the bottom (see illustration to the left).
