E34 M5 Intake Resonance Flap Overview and “How to Test”

This document covers what the Intake Resonance Flap (IRF) is, when it operates, the benefits it offers, and how to test it.

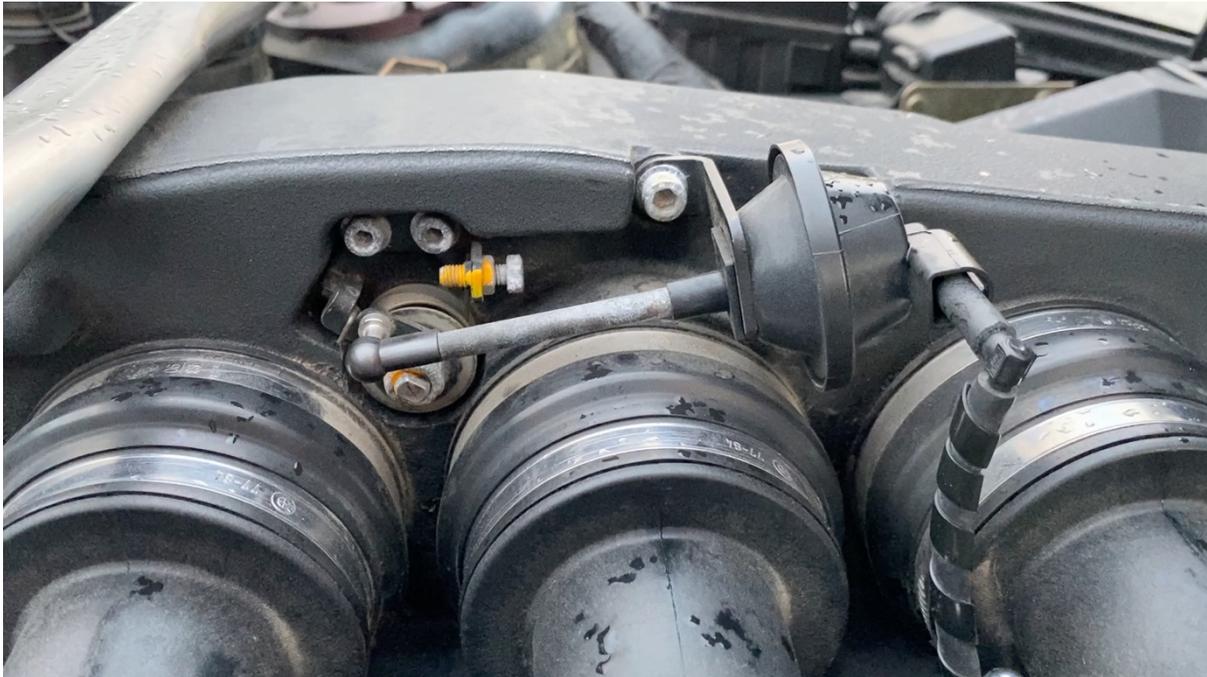
Video of Self Test

At every engine start the Resonance Flap does a self-test. Failing the self-test does not throw a check engine code and cannot be determined any way except visually. The video above shows what the self-test “should” look like. As you can see there are two “actuations” of the flap at engine start – not at key 1 or key 2.

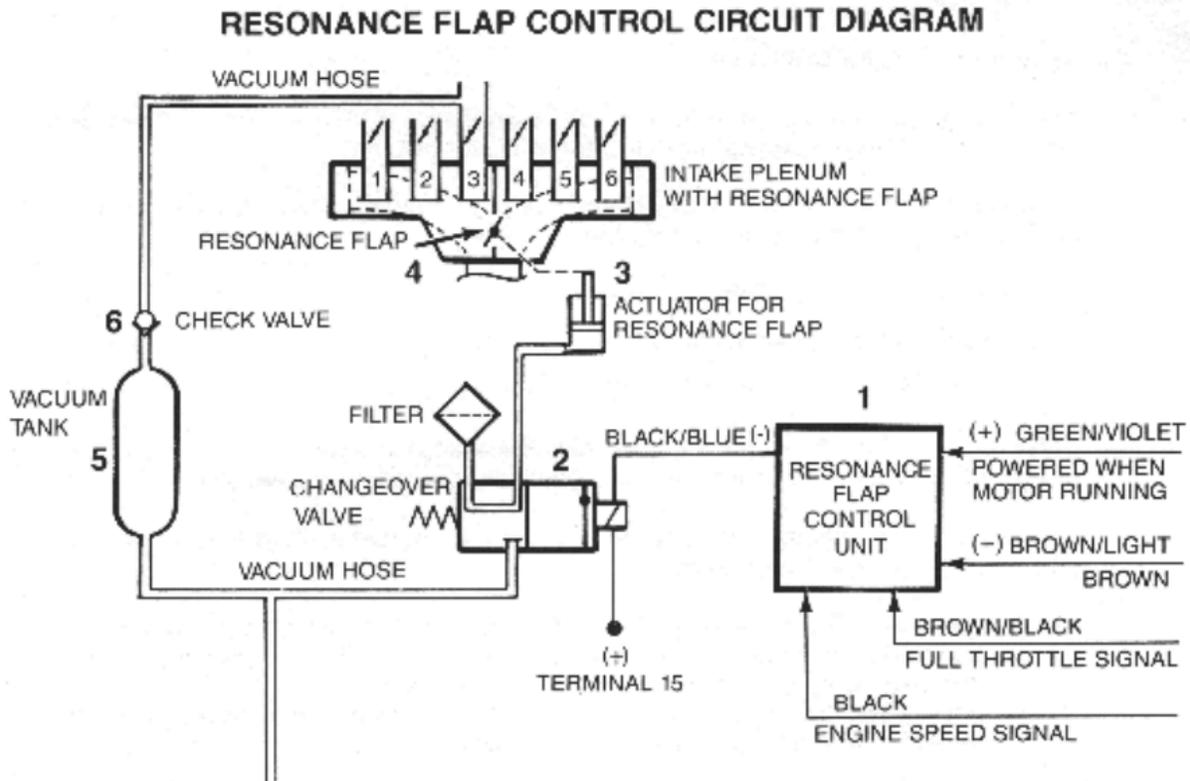
Picture #4: Resonance Flap Control Unit Diagram

If the self-test fails, or only actuates once, then there are several areas to be investigated. See Picture #4 below for components of the system.

1. **Vacuum reservoir**: There is a vacuum reservoir as part of the system This reservoir is intended to allow the Flap to actuate and close at high engine RPM, when manifold vacuum is close to zero. This vacuum reservoir holds enough vacuum to actuate the flap 6 times. The first test should be to let the engine run for a few seconds at idle to replenish this vacuum reservoir, turn the engine off, and then immediately turn the engine back on. If the Resonance Flap self-test now works, then you have a vacuum leak from the reservoir or from the check valve between the reservoir and the engine. A new reservoir and all associated parts can be purchased from Angry Ass [here](#).

2. **Actuator**: The vacuum actuator can have a blown diaphragm internally. This can be checked by removing the vacuum hose at the 90” nipple, and then sucking gently on the hose. If the flap actuates then the actuator itself is ok. If it does not then the actuator is broken and must be replaced. This part is NLA but is produced by Angry Ass and can be purchased online [here](#).

3. **Vacuum Hose**: The vacuum hose can be degraded to the point that when the vacuum is applied to the actuator, the vacuum vents to the atmosphere through a crack or hole in the hose. Testing this requires removing the plenum and then sucking on the vacuum hose where it attaches to the electric changeover valve under the plenum. If the actuator

attached to the plenum works but sucking on the hose at this lower point fails, then the vacuum hose is the culprit and needs replacing.

4. Electric Changeover Valve: If the actuator works when sucking on the vacuum hose attached to the changeover valve, then the valve itself (Part # [11741742711](#)) could be inoperable. This valve has two terminals that when powered with 12v will actuate the valve to send the main vacuum attachment to the actuator. Applying 12v to the terminals will activate the valve – one side is marked with a “+” sign. If you do this while sucking on the main vacuum attachment for the valve, it should activate the actuator. If it does not then your Changeover Valve is broken and needs replacing.
5. Control Unit: Finally, if the Changeover valve works in step 3 above, then your Resonance Flap Control Unit is probably malfunctioning. This is in the E-box underneath the relays. You can test it using the diagram below or replace it. Part # 13621316687 - \$500 new!
